New York State Department of Transportation

Yellow Flag NB2228W015

Flag Date: March 25, 2022

BIN: 1065318

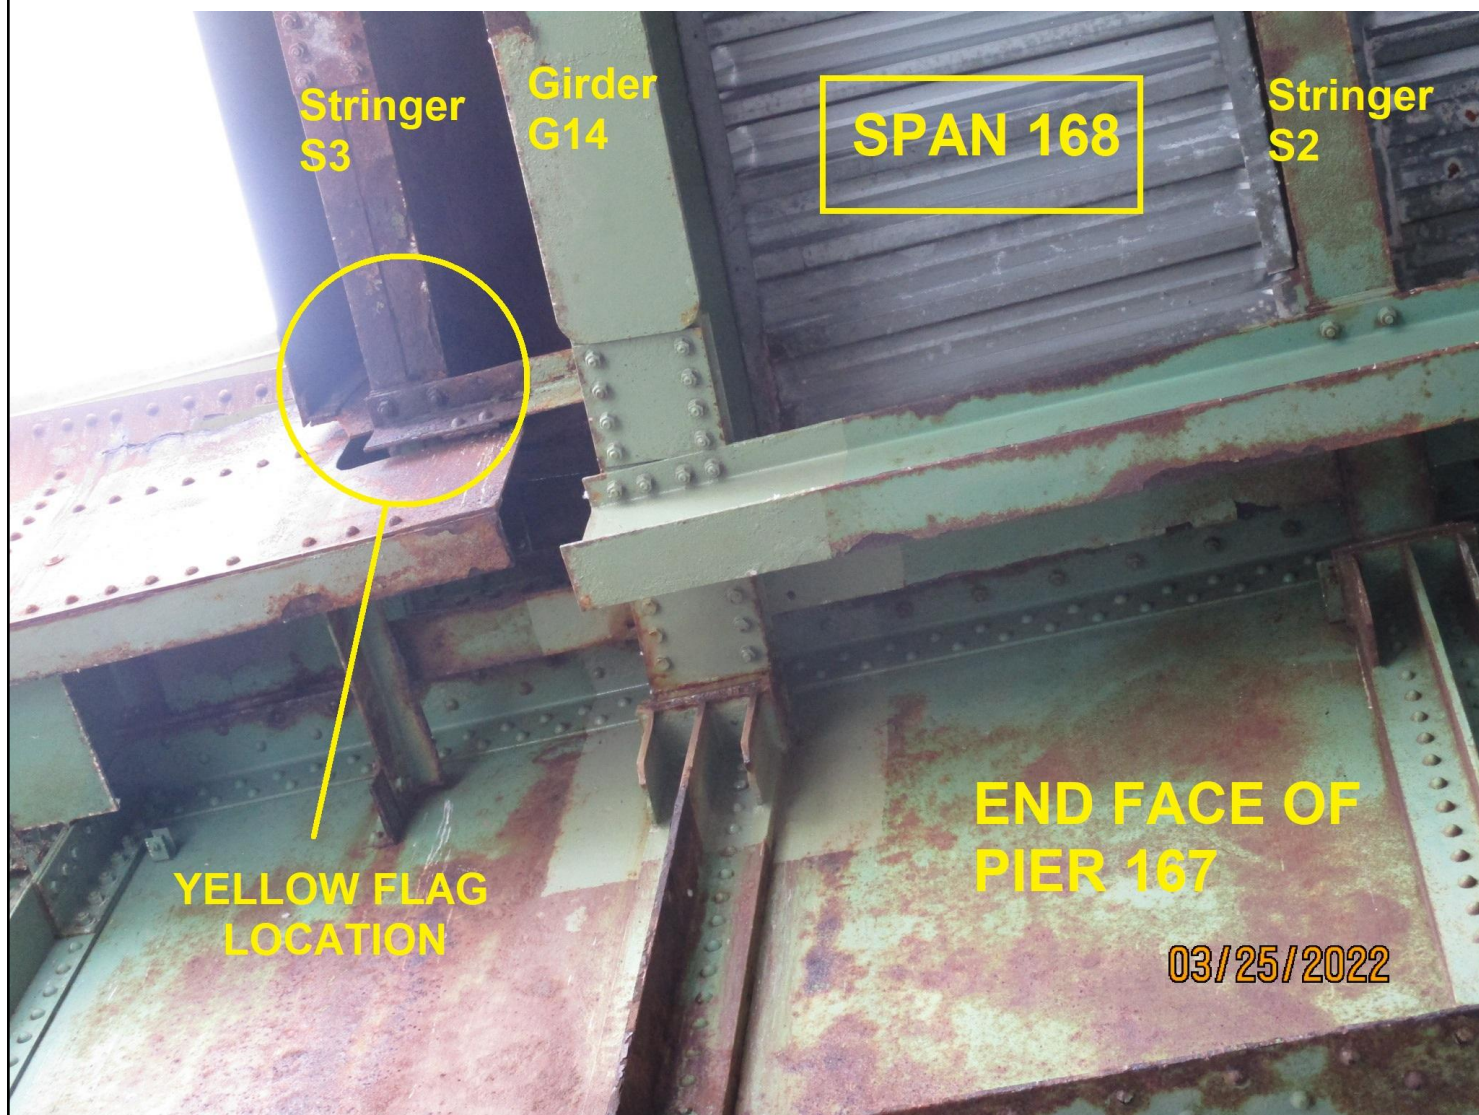
Photo Number: 1

Attachment Description: General view of the flagged condition at Stringer S3 in Span 168 at Pier 167. Looking Begin.

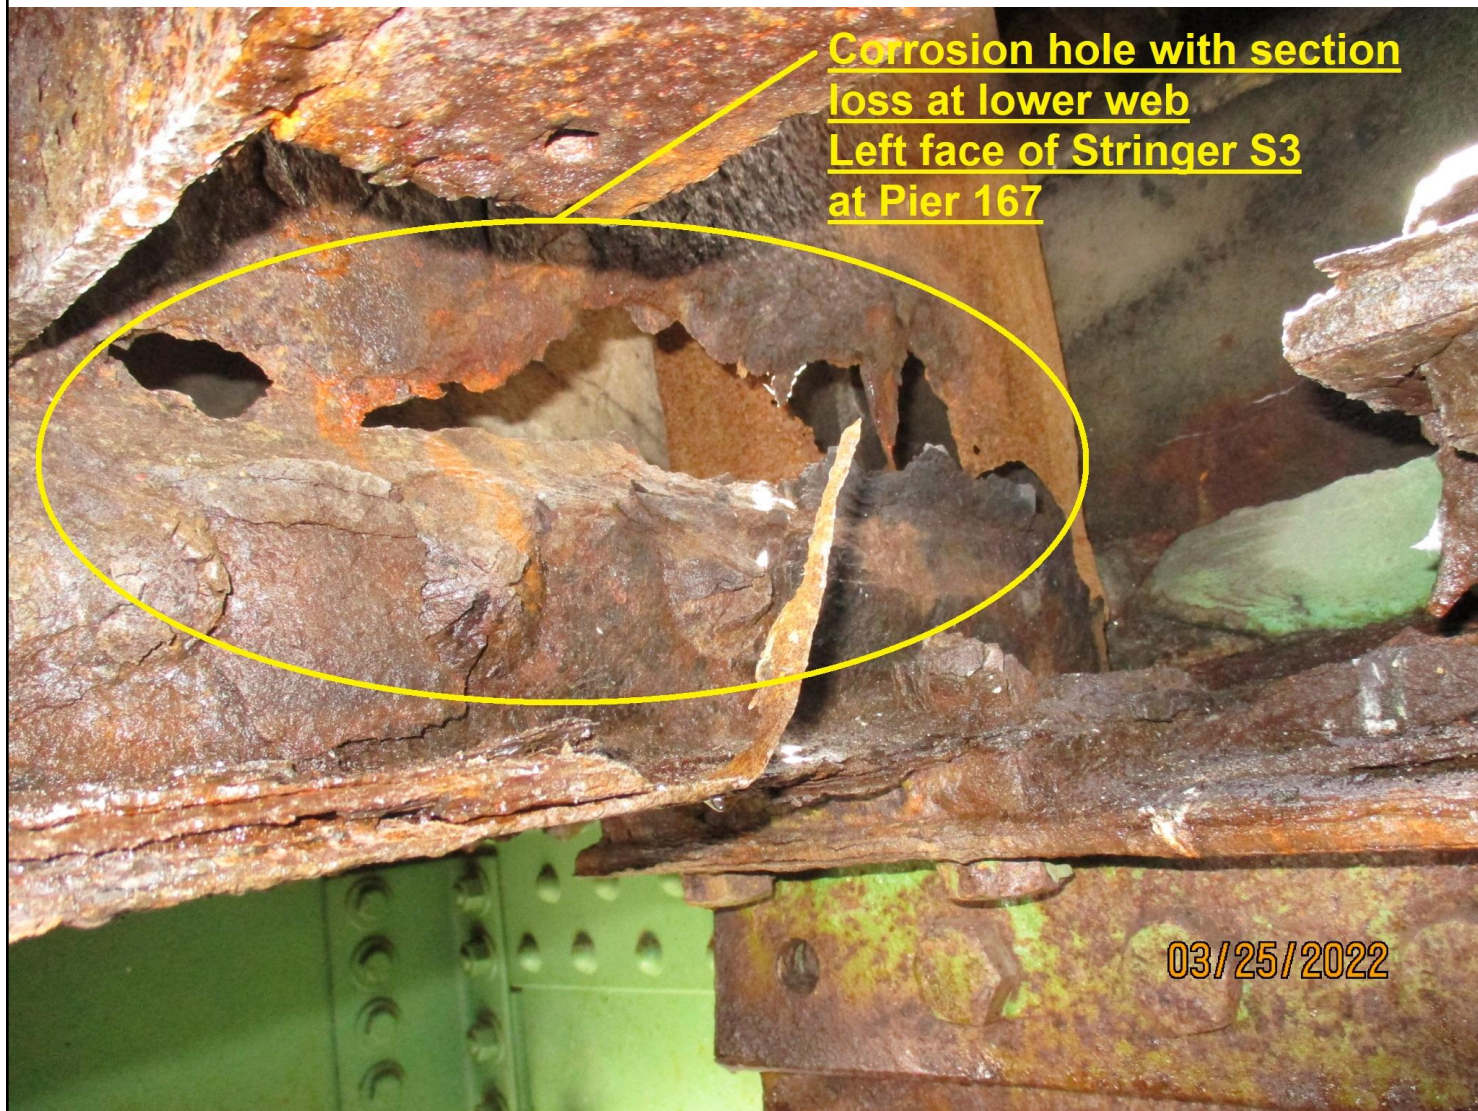
Photo Number: 2

Attachment Description: The left face of Stringer S3 in Span 168 at Pier 167. The lower web of the stringer exhibits two corrosion holes with section loss above the bottom flange. Looking Begin Right.

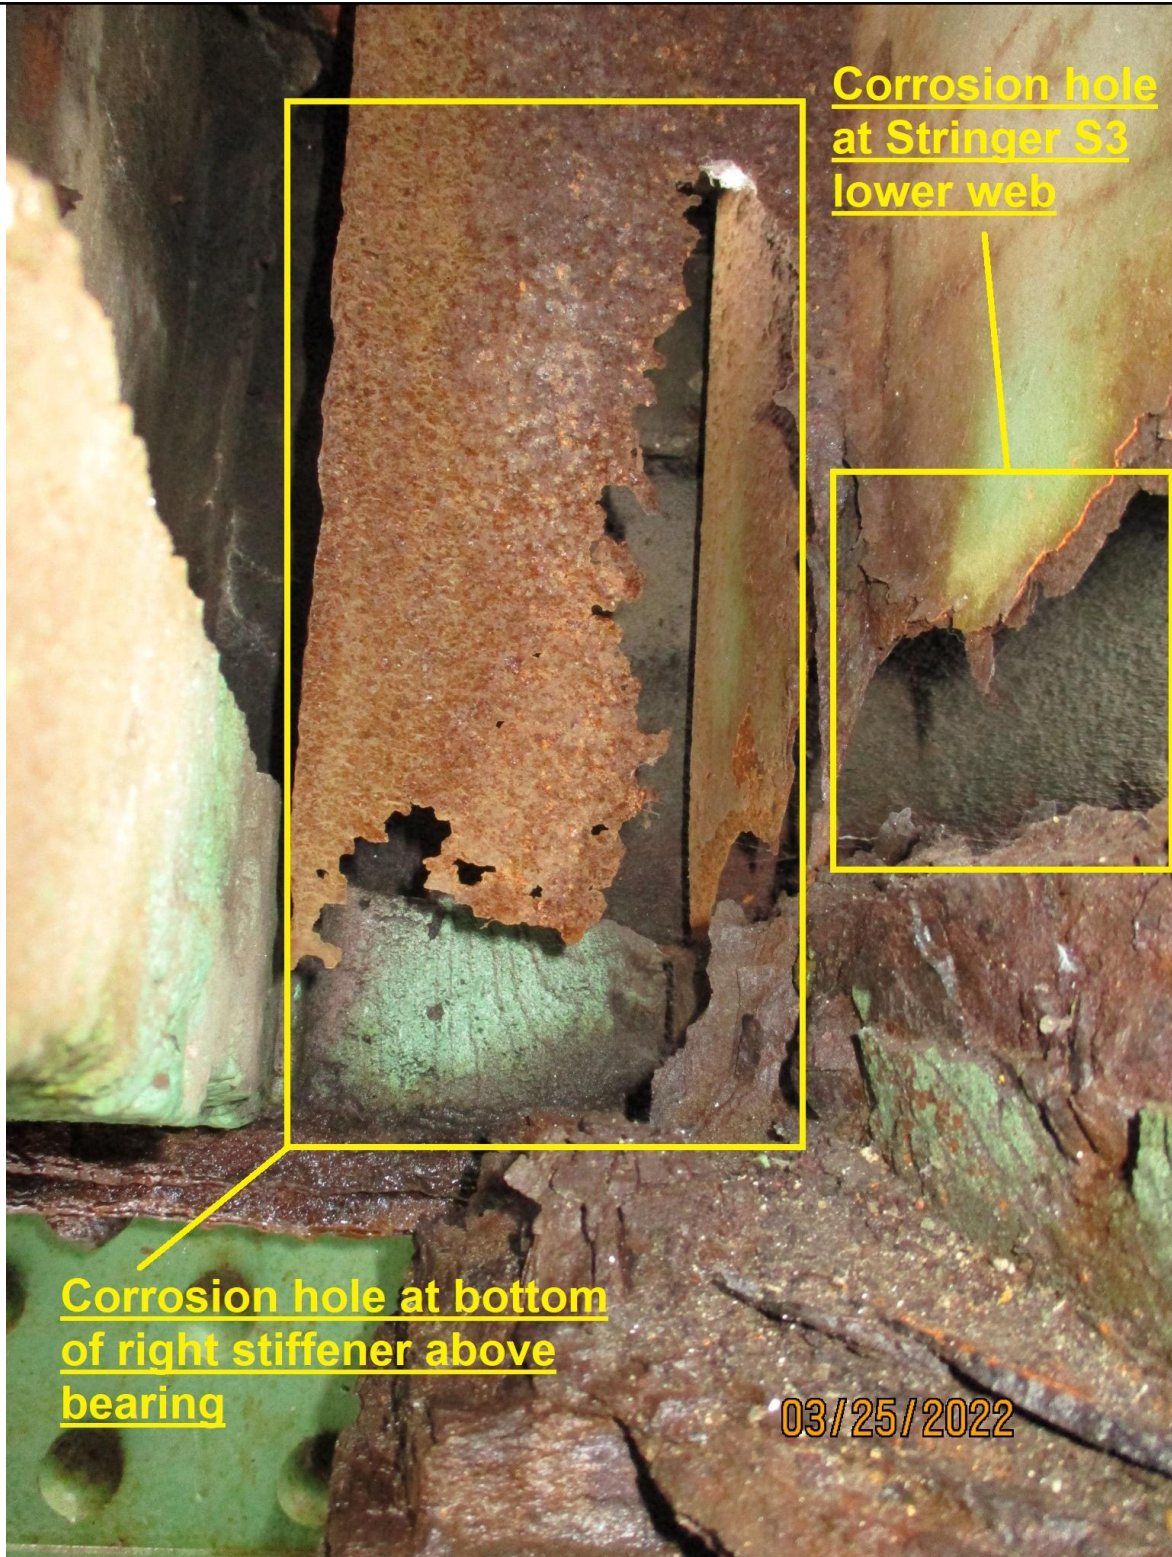
Photo Number: 3

Attachment Description: The right face of Stringer S3 in Span 168 at Pier 167. The right bearing stiffener above the bearing exhibits corrosion hole at the bottom of the stiffener with corrosion hole at lower web of stringer. Looking Begin.

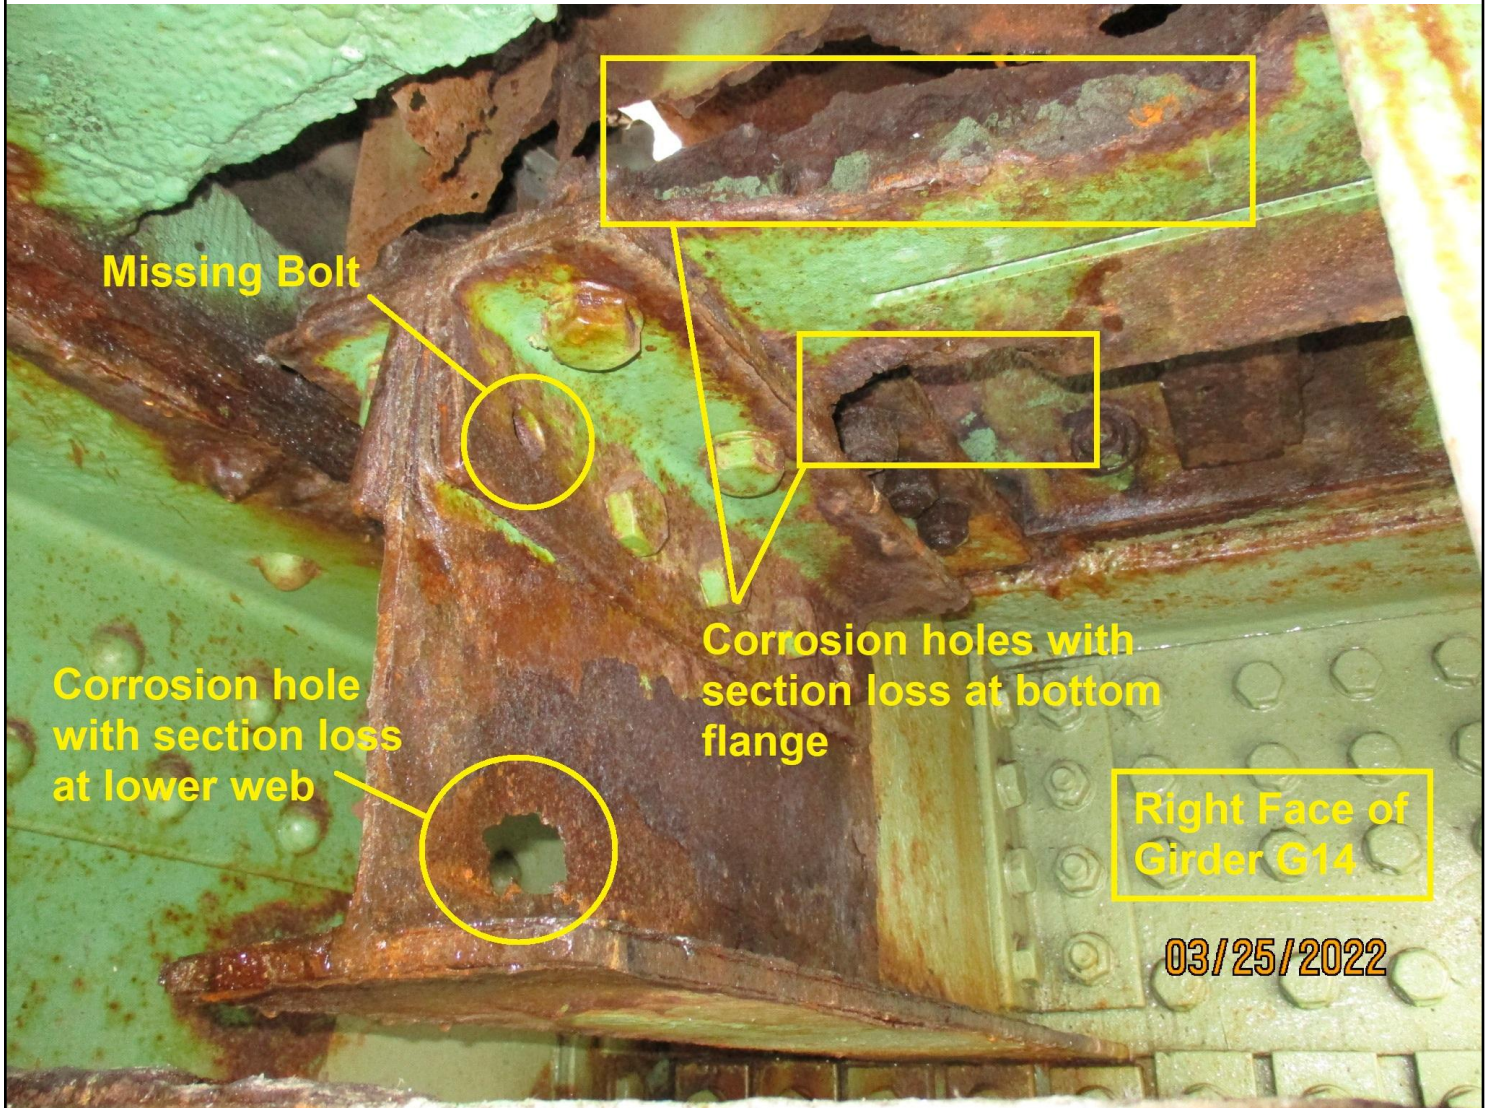
Photo Number: 4

Description: The end of Stringer S3 in Span 168 at Pier 167 exhibits severe section loss at the lower web and bottom flange. The stringer exhibits two corrosion holes for 16"L x 3"H and 1-1/2" (previously 1") diameter in the lower web above the bottom flange (starting at the end of the stringer) with knife edging along the holes with an average of 0.34" remaining thickness measured (RTM) resulting in an overall section loss of 20% for 2" wide surrounding the holes (no change from previous) - (Photo 2). The right stiffener above the bearing exhibits one corrosion hole for 10"H x up to full width at the bottom of the stiffener (no change) - (Photo 3). Also, the first stiffener (counting from Pier 167) at the right face of the stiffener exhibits one corrosion hole for 4"H x full width at the bottom of the stiffener. In addition, the bottom flange of the stringer adjacent to the end side of the bearing plates at Pier 167 exhibits one corrosion hole for 5"L x 2"W at the left side bottom flange and one corrosion hole for 10"L x 2"W at the right side bottom flange with up to 40% section loss surrounding both holes (no change) - (Photo 4).

The stringer rests atop of cantilevered lateral support beam which is framed into the web of Girder G14 with connection angles. The lower web of the support beam exhibits a 2" diameter corrosion hole with up to 60% section loss in the surrounding areas above the bottom flange (no change). The top flange angle of the lateral support beam below Stringer S3 exhibits 1 out of 5 missing bolts. The connection angles between the support beam and the web of Girder G14 are in good condition. (Photo 4)

Attachment Description: The cantilever support beam below Stringer S3 in Span 168 at Pier 167. The lower web of the support beam exhibits corrosion hole with section loss. Also, the top flange angle below the stringer exhibits missing bolt. In addition, both sides of the stringer bottom flange exhibit corrosion holes with section loss. Looking Left.

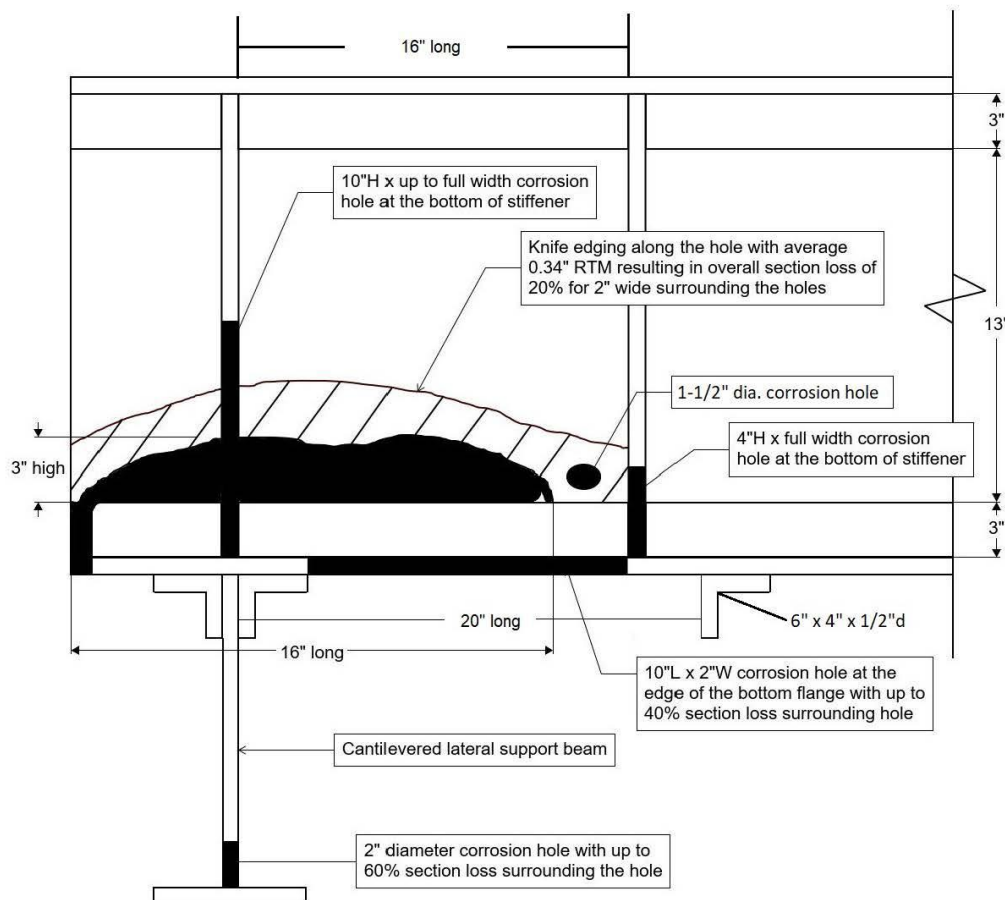
Right Face of Stringer S3 Sketch in Span 168 at Pier 167
N.T.S

- Measured as-built web thickness = 0.43"
- Corrosion hole for 5"L x 2"W at the edge of the left side bottom flange not shown in sketch.
- The stringer rests atop cantilevered lateral support beam which is framed into the web of Girder G14 with connection angles which is in good condition.
- Missing 1 out of 5 bolts at the top flange angle of the lateral support beam below stringer.
- The stringer directly supports the curb and railing posts above at the intersection with ramp.

Attachment Description: SN 168 S3 at Pier 167 Sketch

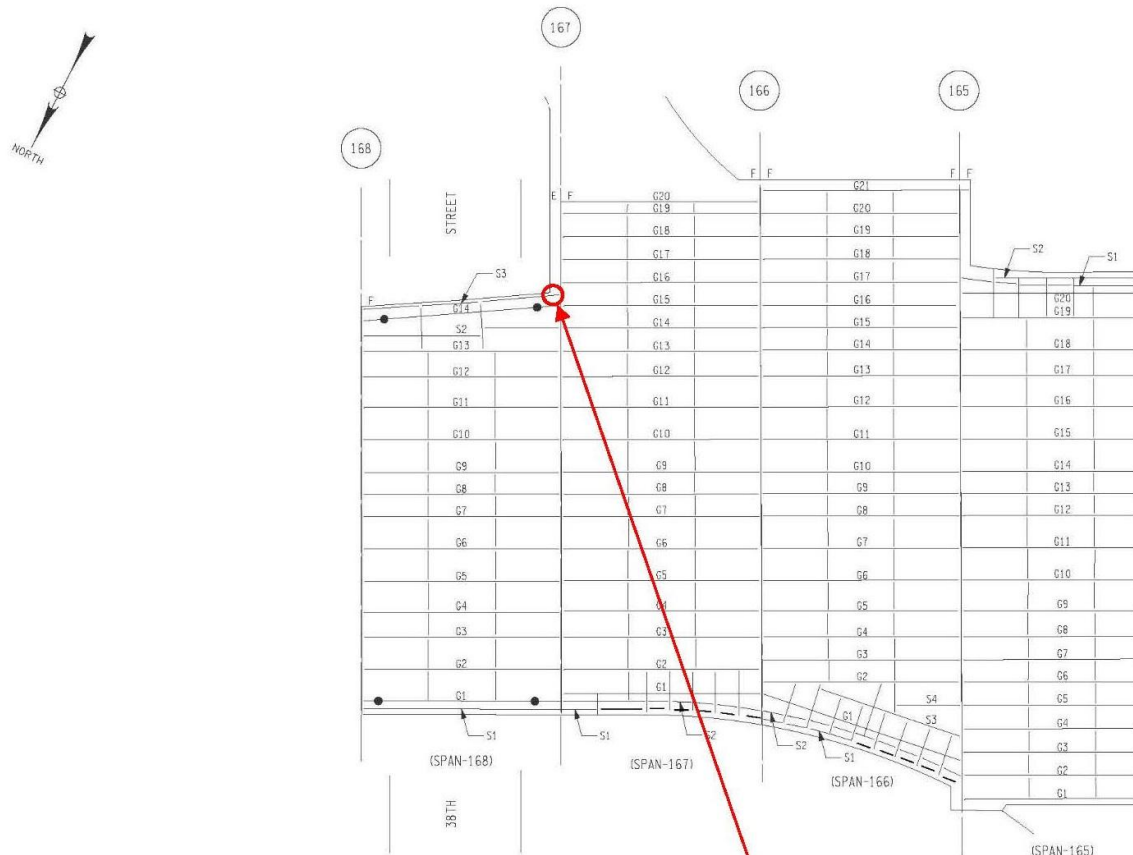
Attachment Description: SN 168 S3 at Pier 167 Framing Plan

**YELLOW FLAG
LOCATION
No. NB2228W015**
